Detecting Pavement Distresses Using Crowdsourced Dashcam Camera Images

May 2021

Final Report

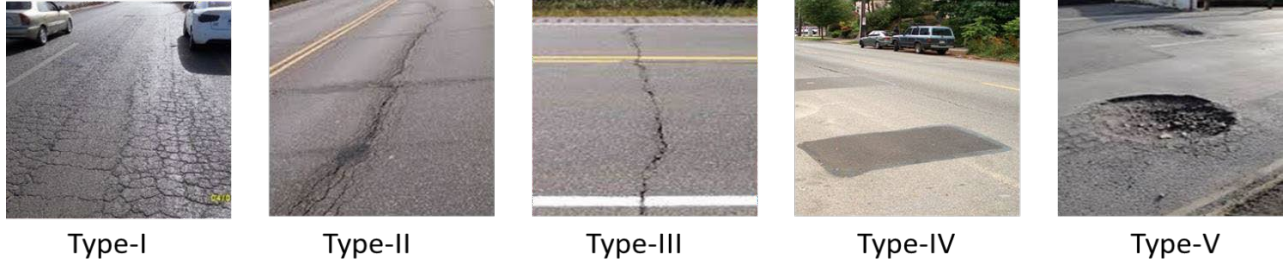
Figure 2 presents the damage types that were identified in the damage detection models. In this project, each damage type is represented with a class name:

- 1) Type-I pavement damage is top-down fatigue cracking (Alligator Cracking), which is the most common distress in asphalt pavements. This type of damage size can vary from 6 inches to 3 feet across. The size of damage that is discernible in the dashcam images has medium to high severity.

- 2) Type-II damage is longitudinal cracking that propagates parallel to the pavement centerline. Generally, high severity cracks with crack openings greater than a half-inch can be discerned in the images.

- 3) Type-III damage is transverse cracking that propagates perpendicular to the centerline of the roadway.
- 4) Type-IV consists of patching areas that have a high potential for crack initiation and distress growing and should be monitored regularly.

- 5) Type-V damage is a pothole, and is a common damage in asphalt and concrete pavements. Potholes are holes in the roadway that vary in size and shape and are the most dangerous distress and lead to the biggest increase in crash risks, especially on high-speed roads.

Figure 2. Pavement damage types, Type-I: Alligator Cracking, Type-II) Longitudinal Cracking, Type-III) Transverse Cracking, Type-IV) Patching, Type-IV) Potholes.

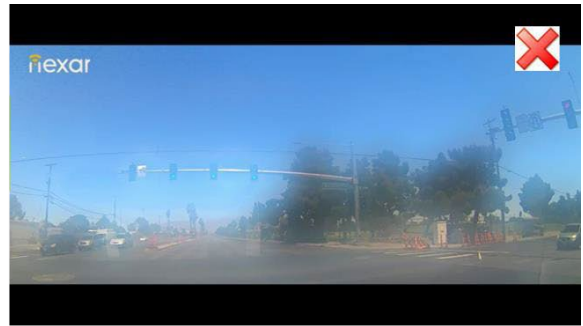
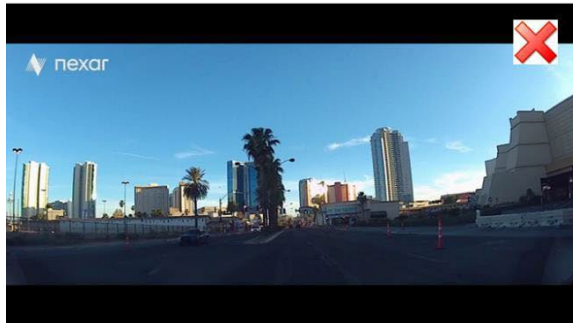
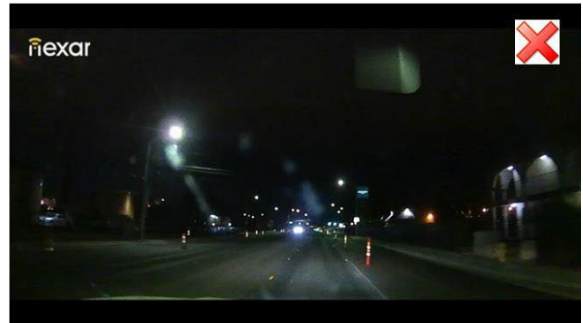
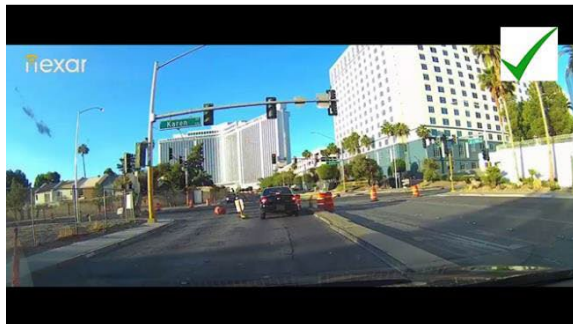
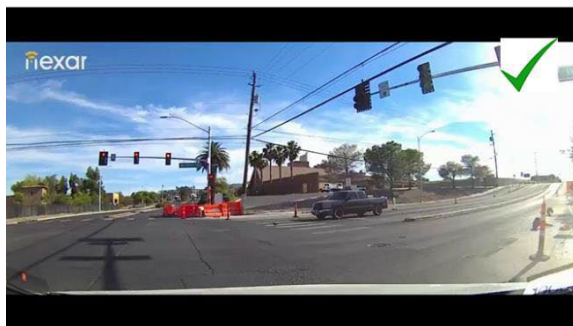
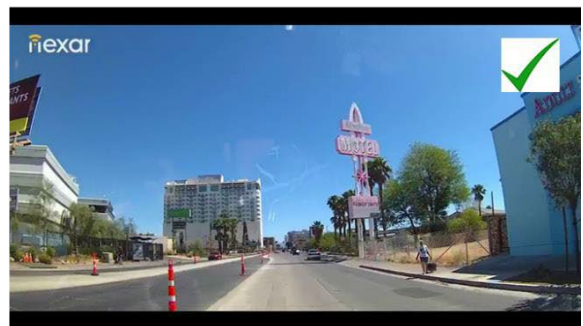
Images were taken from several dashcam cameras at different speeds. Some of the images were completely blurred, and some did not have a section of the road. Also, some of the images had very weak illumination that was not suitable for model training. In this step, the provided images were investigated, and unusable images were discarded. Figure 3 shows examples of acceptable and not acceptable images for damage detection purposes.

a) Discarded Images

b) Acceptable Images

Figure 3. Examples of the acceptable and discarded images for roadway damage detection.

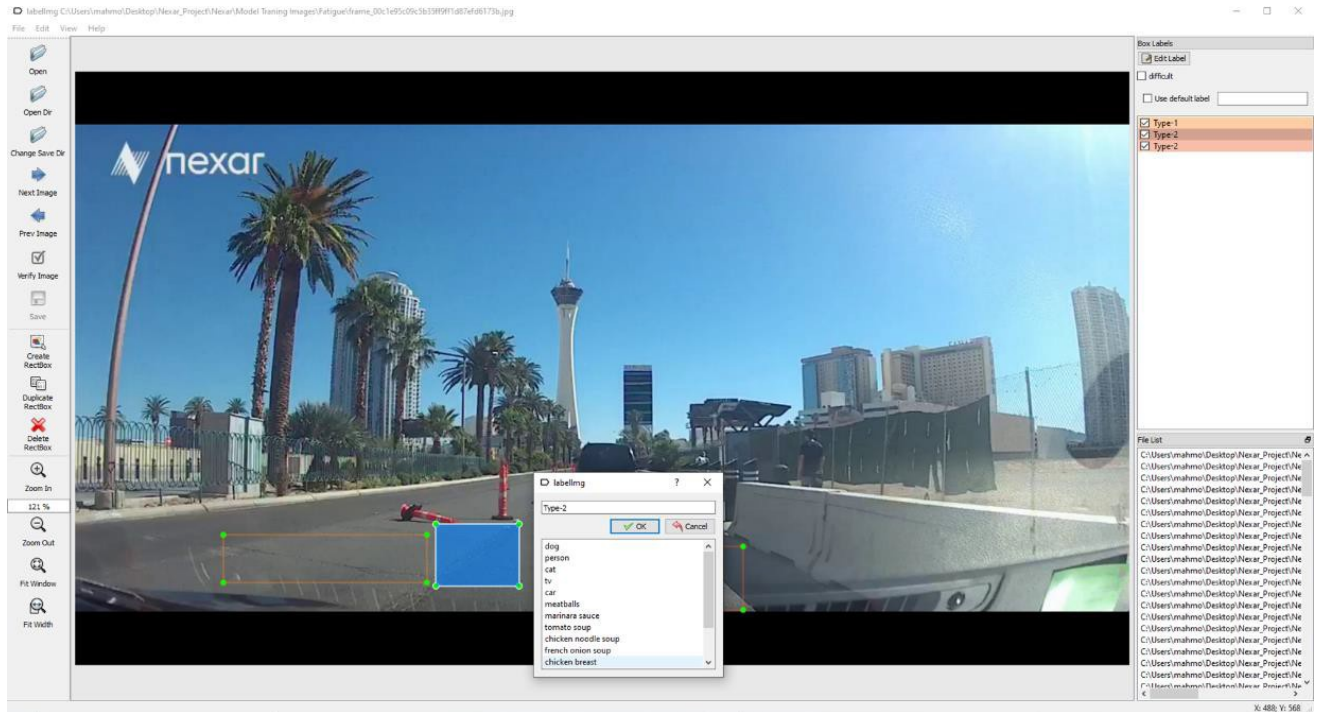
After reviewing the images, the accepted images were annotated using the open-source application LabelImg V 1.8.5 (LabelImg, 2018). This application is a graphical image annotation tool written in Python with a graphical interface. Instances of damage types and the surrounding bounding box were determined manually. LabelImg saved annotations as XML files in PASCAL VOC format. Figure 4 shows the manual annotation of the images using LabelImg.

Figure 4. Data annotation using LabelImg.

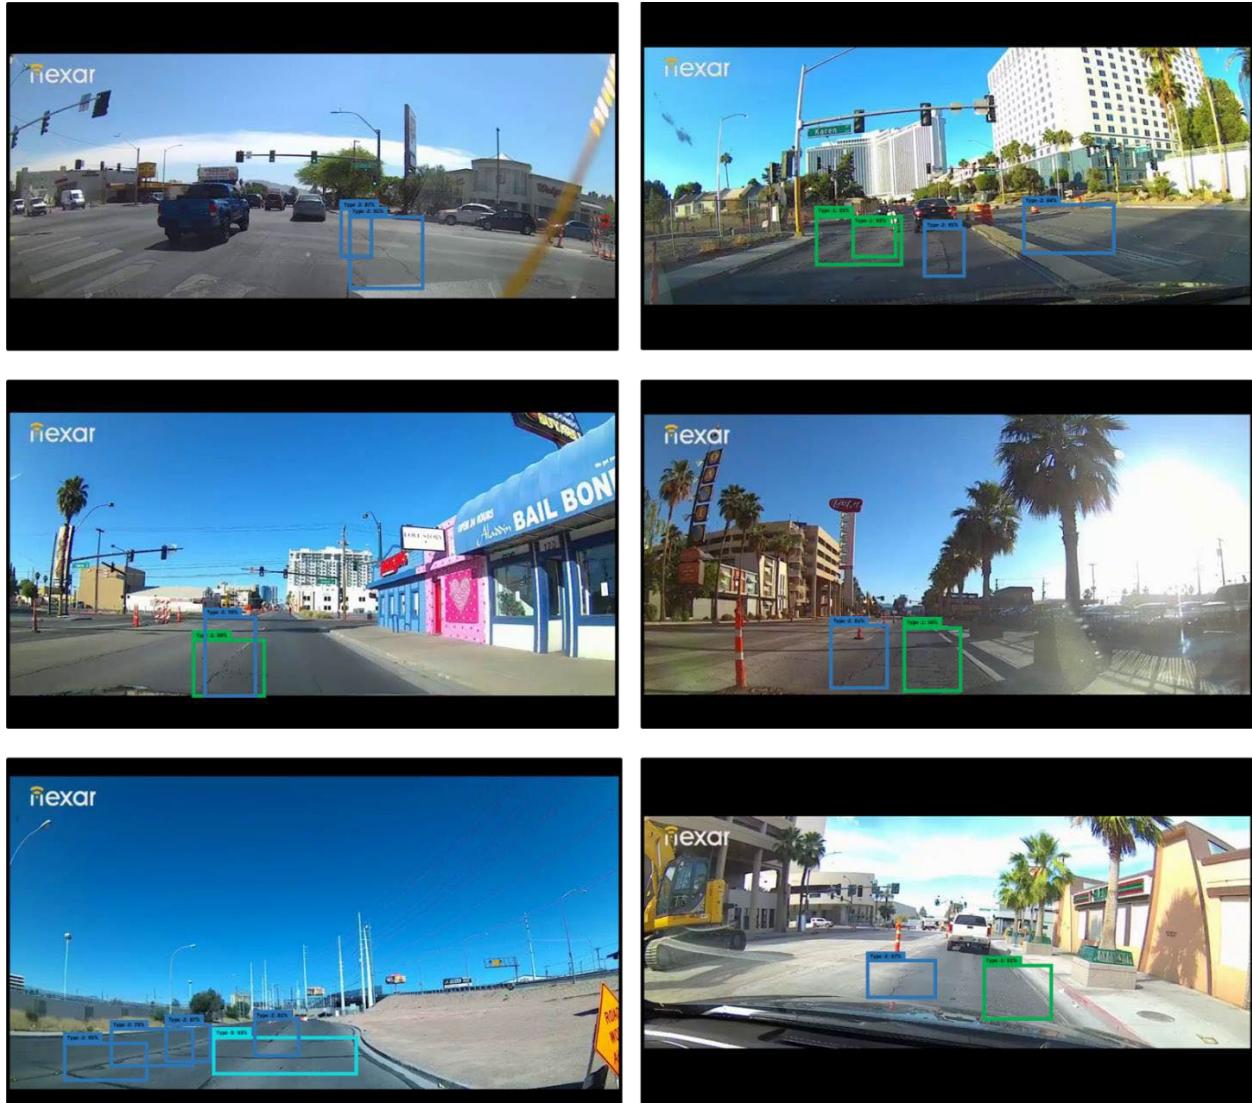
Figure 5 depicts a sample of detected damage types using the models described above. Different colors were used to represent the damage types. As observed, each pavement damage was detected separately in the provided images.

Figure 5. Examples of pavement damage detection in Nexar images.

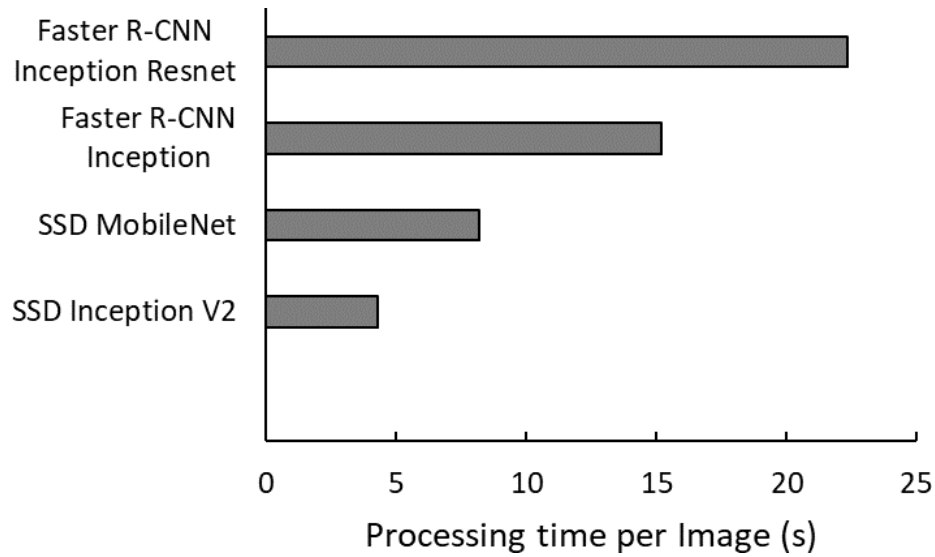
The operation speed of each model is presented in Figure 6. The speeds were recorded from the same PC with the same configuration. The SSD MobileNet had the highest speed among the object detection models. SSD Inception V2 was almost two times slower than SSD MobileNet. The Faster-RCNN models had the lowest operation speed. The Inception Resnet was 1.5 times slower than the Inception algorithm in the Faster-RCNN model.

Figure 6. Processing time of detection models.

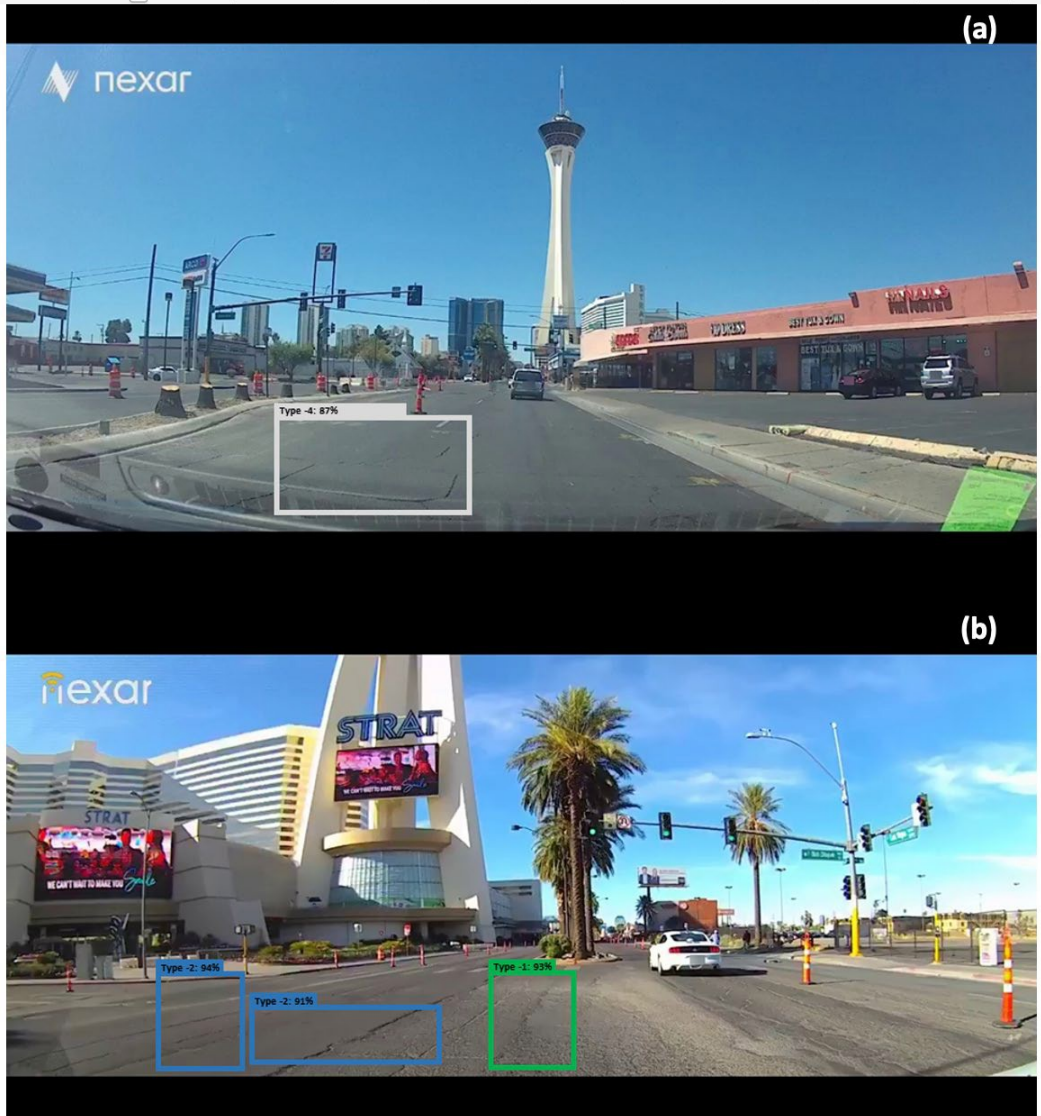
Finally, an error analysis was conducted on false positive (FP) and false negative (FN) instances. Examples of FP are shown in Figure 7. In some cases, the windshield stickers and reflections were the reason for the FP instances (Figure 7(a)). There were also instances where the side curb and their edges were detected as pavement damages (Figure 7(b)). In Figure 7(c) and Figure 7(d), a utility hole and a steel road plate were detected as pavement distress. In some cases, shadows on the ground were the source of the FN error. FP cases are defined as instances of pavement damage that the model was not able to detect. Patching was not detected in many cases. This could be because of the low number of patching instances in the training dataset.

Figure 7. Sample error of detection models.

Figure 7 (cont.). Sample error of detection models.
