Detecting Pavement Distresses Using Crowdsourced Dashcam Camera Images

August 2021

Final Report

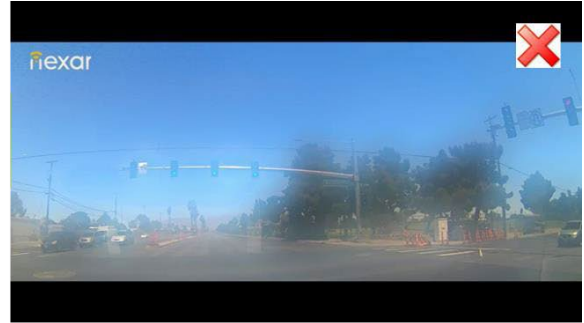
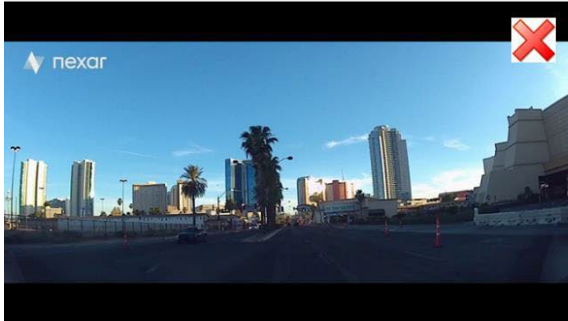
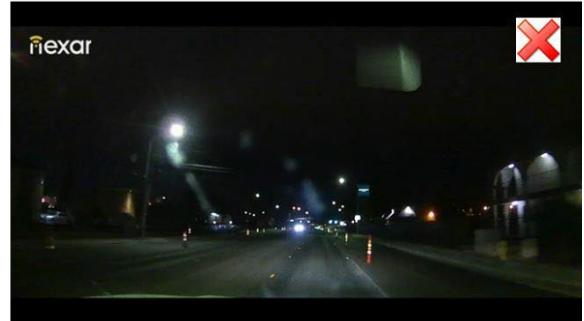
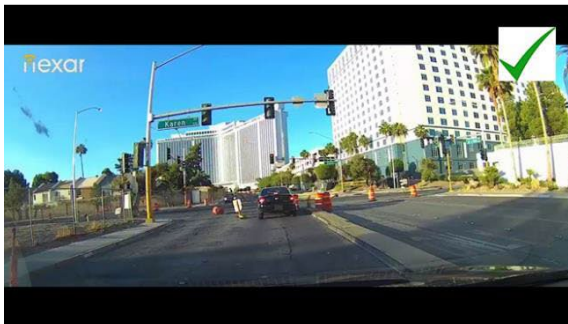
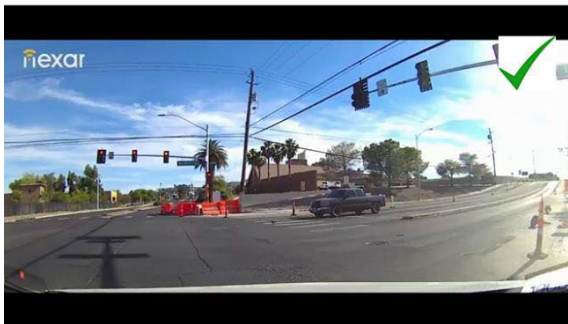
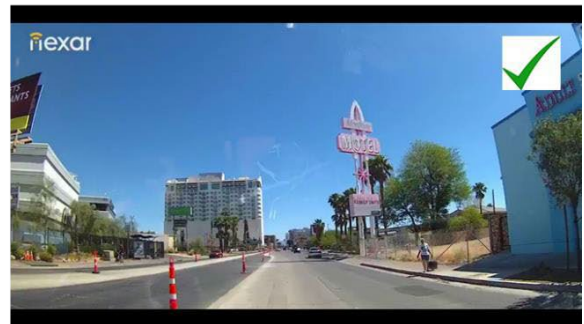
Figure 3. Examples of the acceptable and discarded images for roadway damage detection.

Images were taken from several dashcam cameras at different speeds. Some of the images were completely blurred, and some did not have a section of the road. Also, some of the images had very weak illumination that was not suitable for model training. In this step, the provided images were investigated, and unusable images were discarded. Figure 3 shows examples of acceptable and not acceptable images for damage detection purposes.

a) Discarded Images

b) Acceptable Images

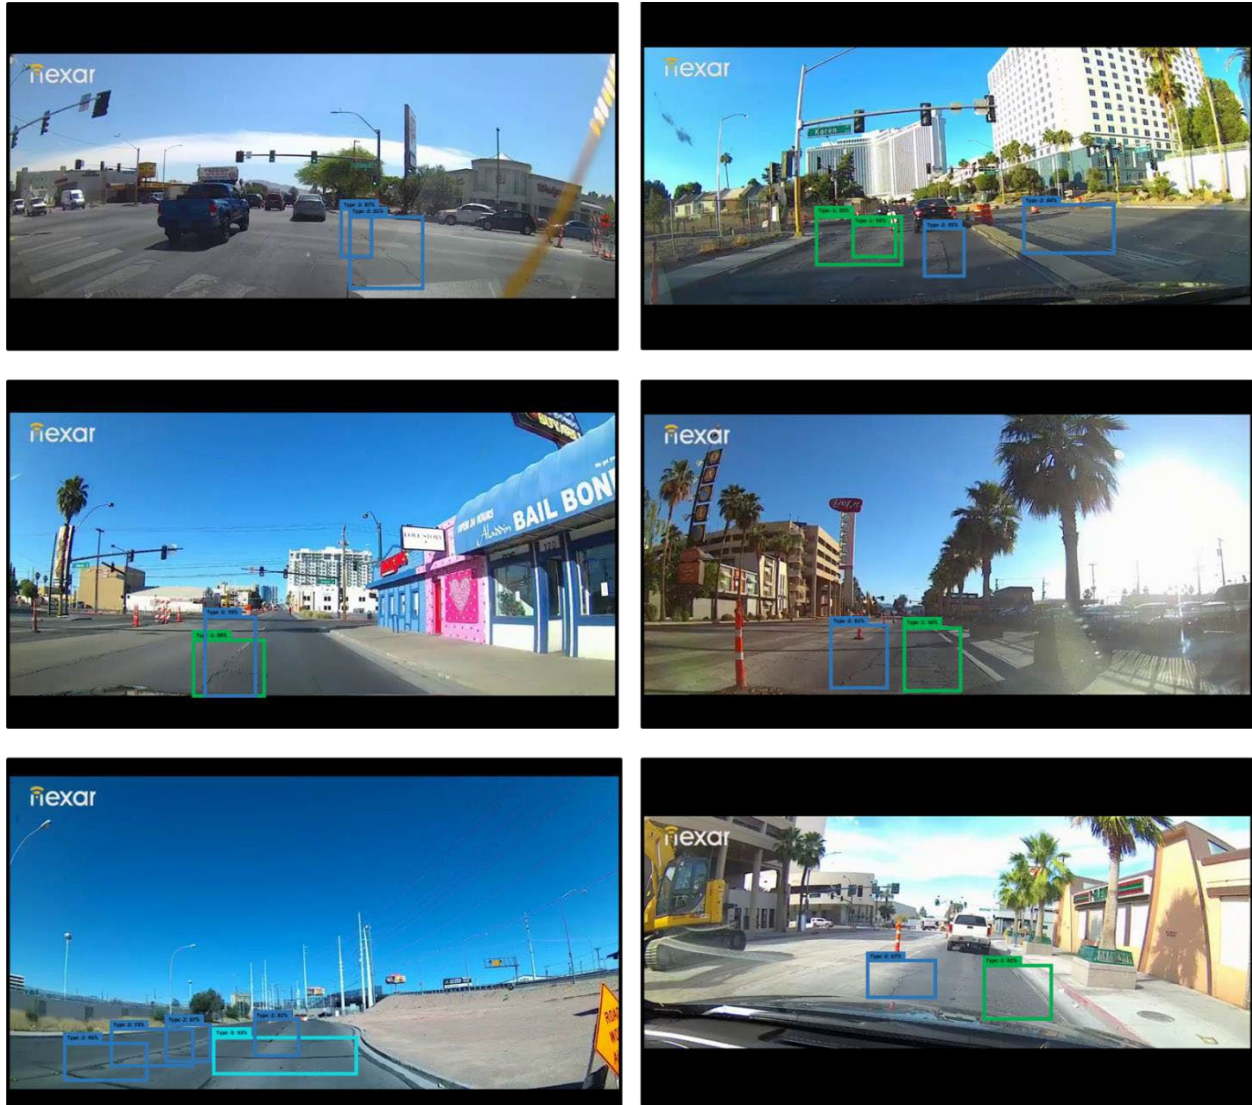
Figure 5. Examples of pavement damage detection in Nexar images.

Figure 5 depicts a sample of detected damage types using the models described above. Different colors were used to represent the damage types. As observed, each pavement damage was detected separately in the provided images.

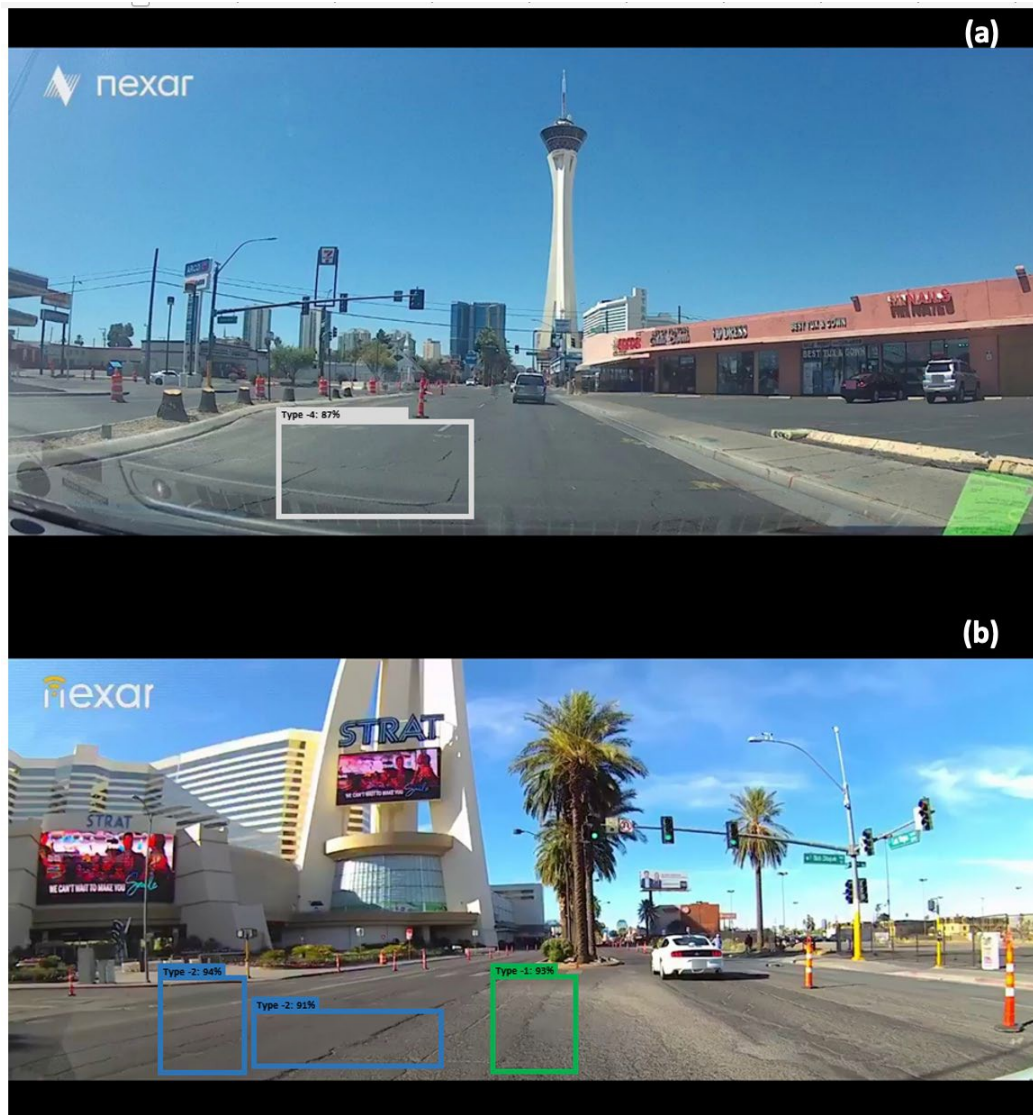
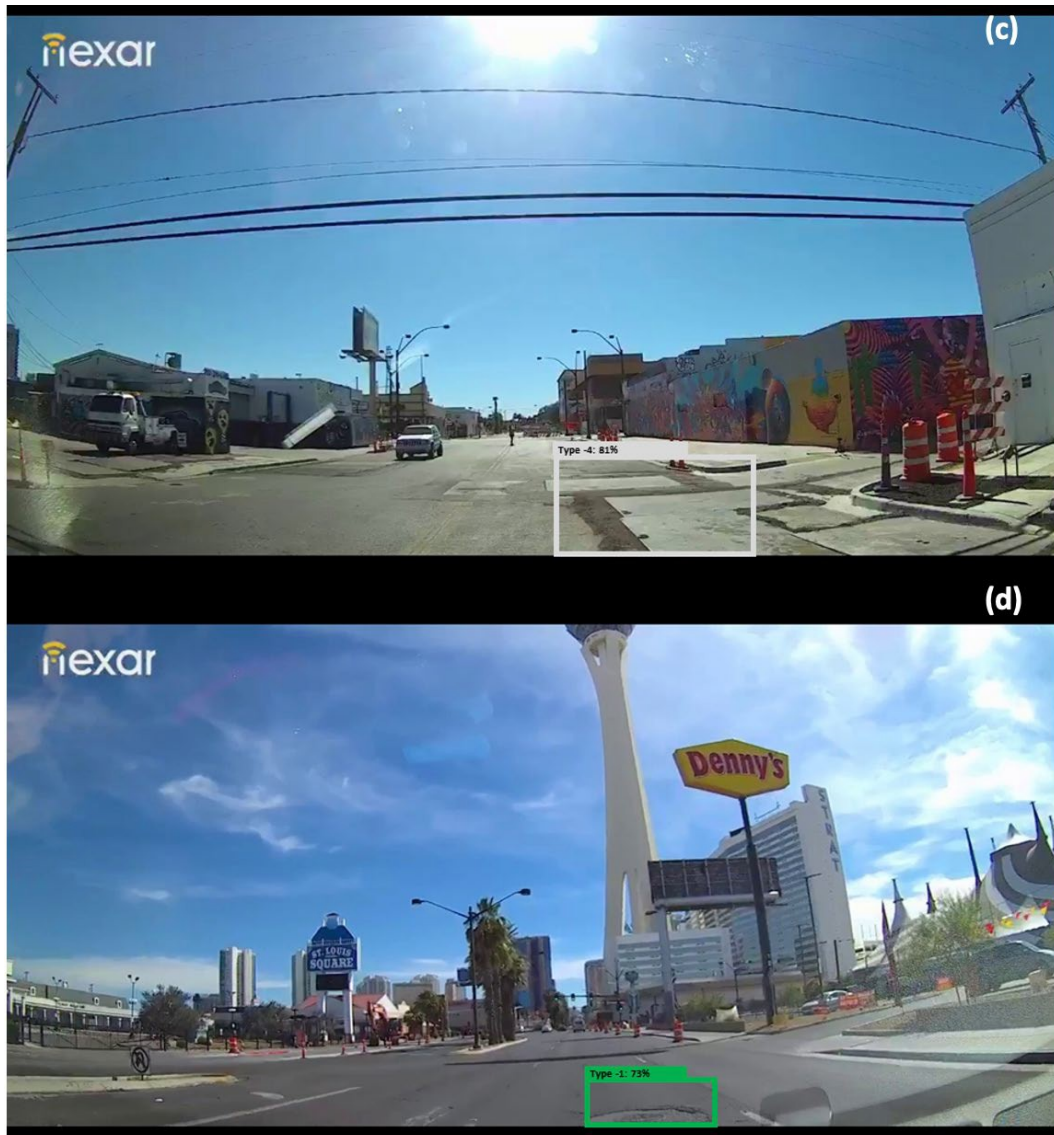
Figure 7. Sample error of detection models.

Finally, an error analysis was conducted on false positive (FP) and false negative (FN) instances. Examples of FP are shown in Figure 7. In some cases, the windshield stickers and reflections were the reason for the FP instances (Figure 7(a)). There were also instances where the side curb and their edges were detected as pavement damages (Figure 7(b)). In Figure 7(c) and Figure 7(d), a utility hole and a steel road plate were detected as pavement distress. In some cases, shadows on the ground were the source of the FN error. FP cases are defined as instances of pavement damage that the model was not able to detect. Patching was not detected in many cases. This could be because of the low number of patching instances in the training dataset.
