Detecting Pavement Distresses Using Crowdsourced Dashcam Camera Images

August 2021

Final Report

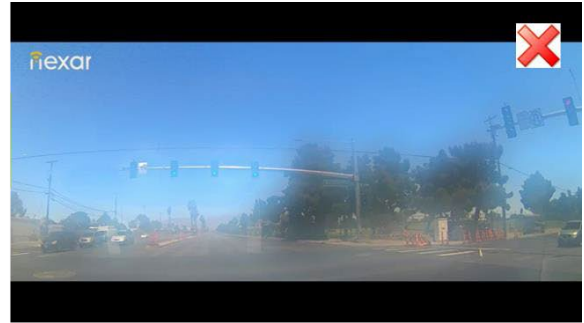
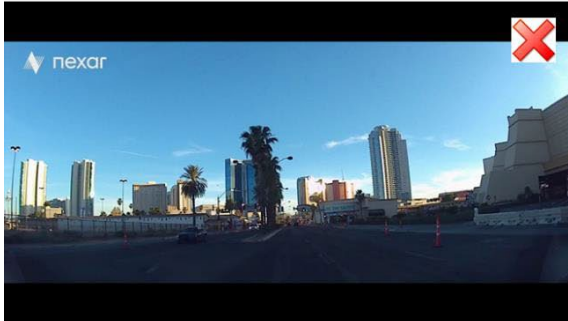
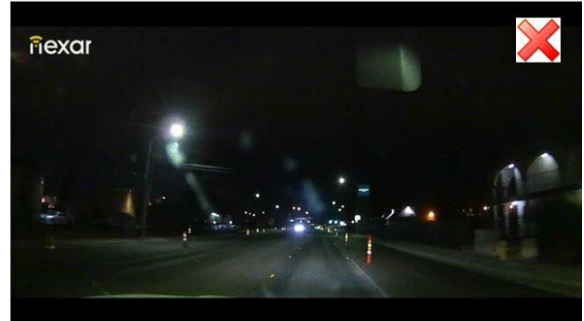
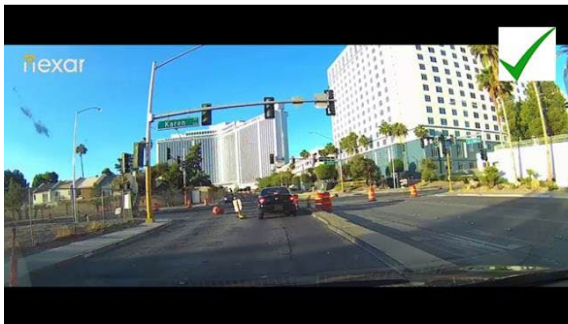
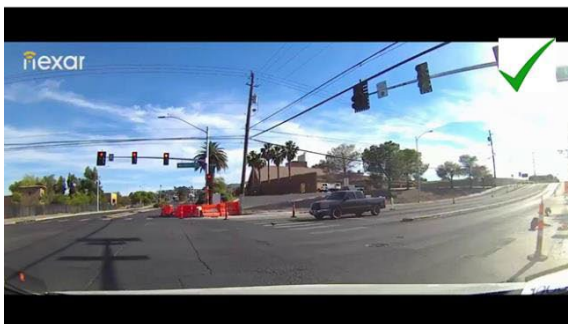
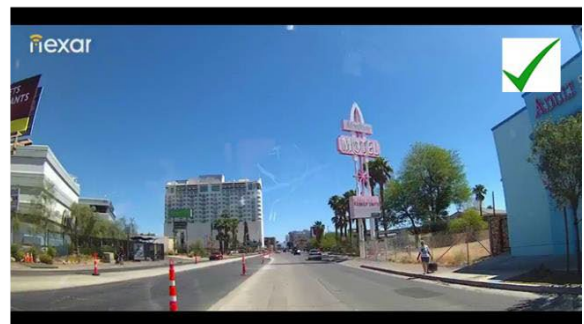
Images were taken from several dashcam cameras at different speeds. Some of the images were completely blurred, and some did not have a section of the road. Also, some of the images had very weak illumination that was not suitable for model training. In this step, the provided images were investigated, and unusable images were discarded. Figure 3 shows examples of acceptable and not acceptable images for damage detection purposes.

a) Discarded Images

b) Acceptable Images

Figure 3. Examples of the acceptable and discarded images for roadway damage detection.

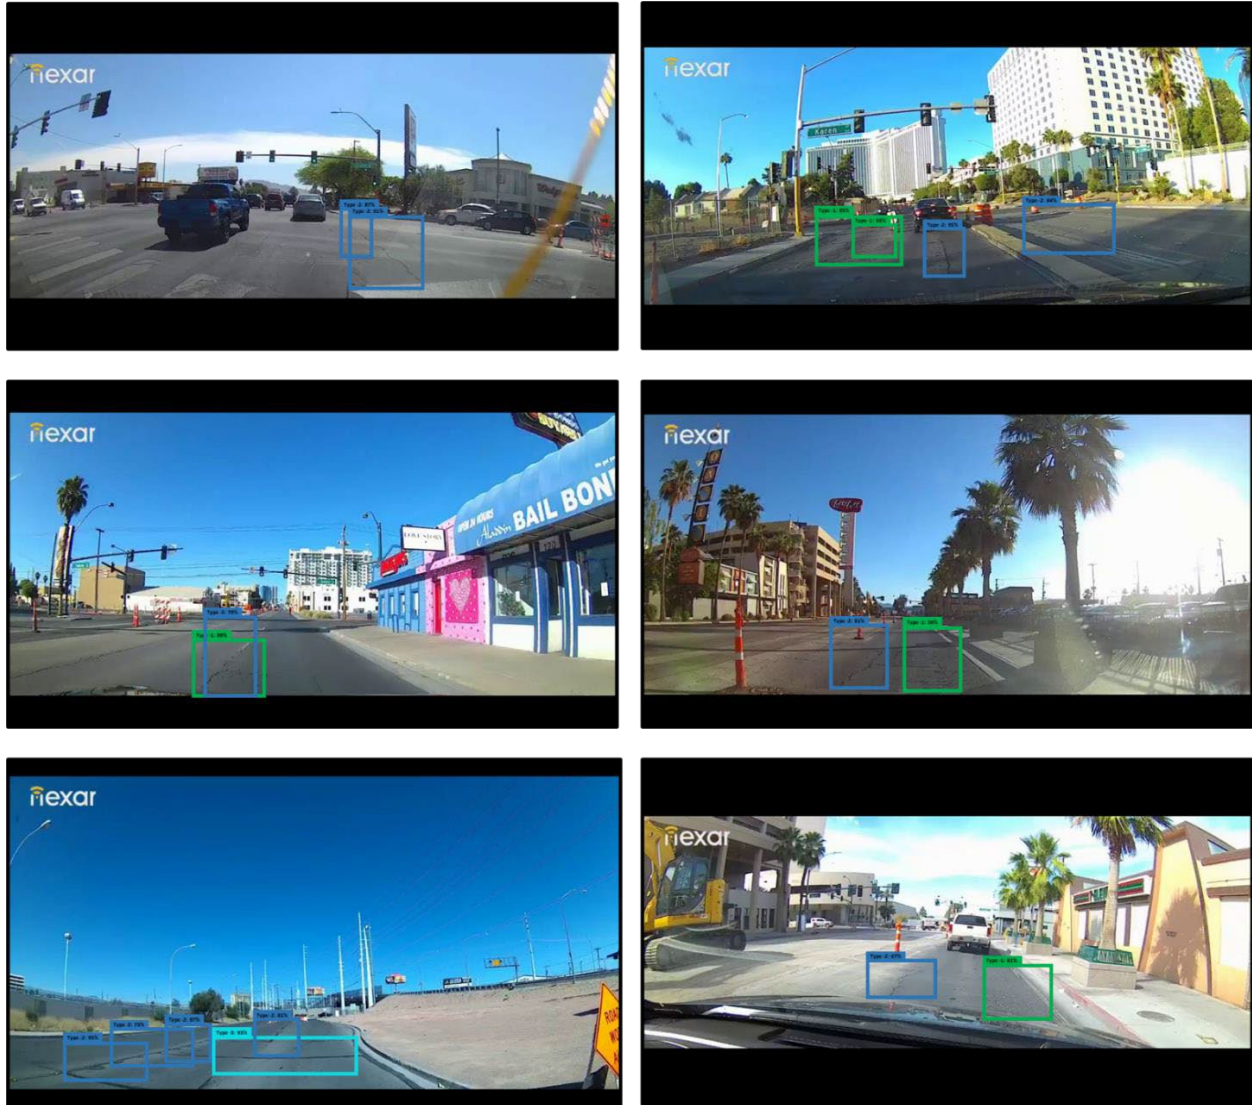
Figure 5 depicts a sample of detected damage types using the models described above. Different colors were used to represent the damage types. As observed, each pavement damage was detected separately in the provided images.

Figure 5. Examples of pavement damage detection in Nexar images.

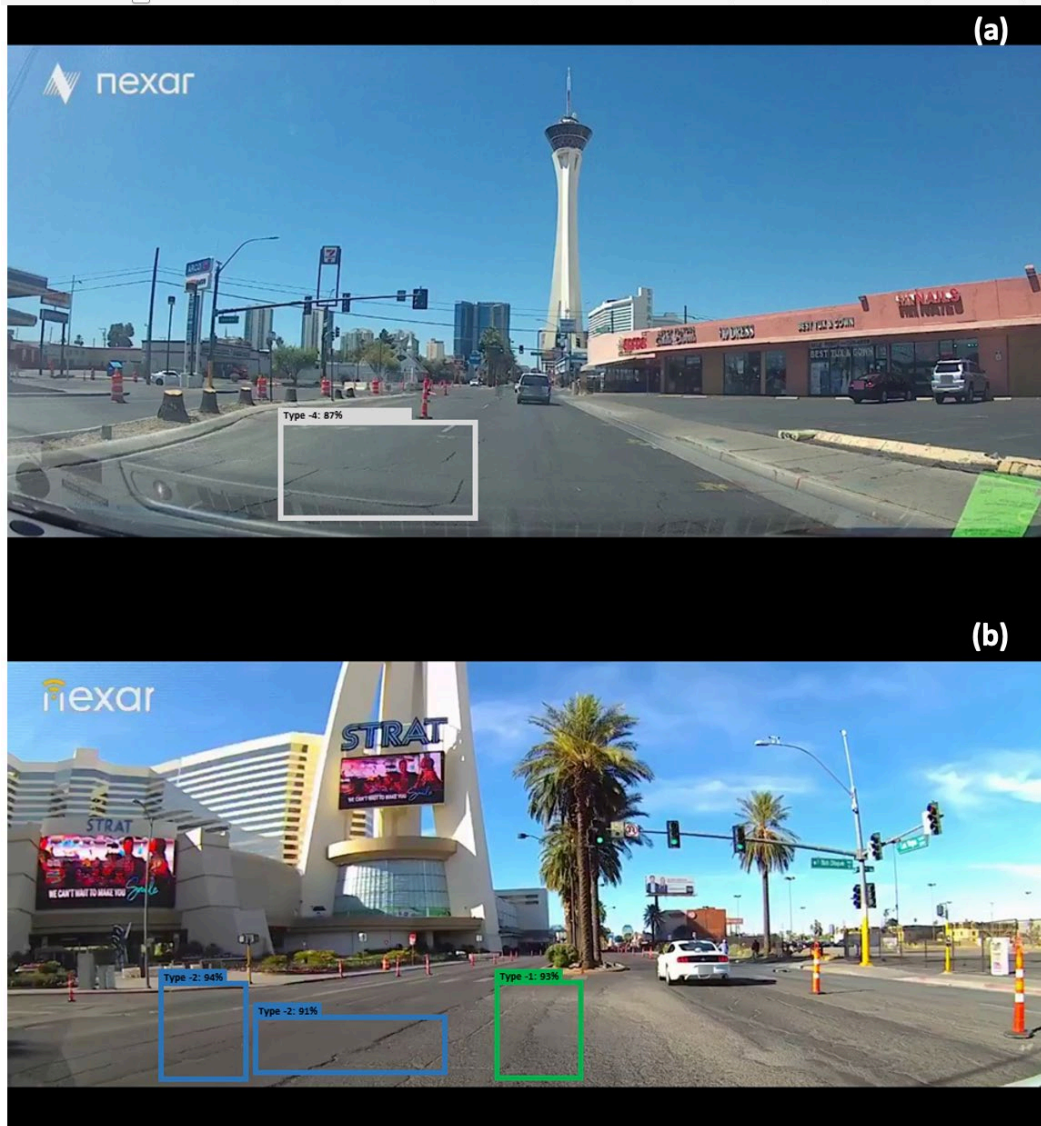
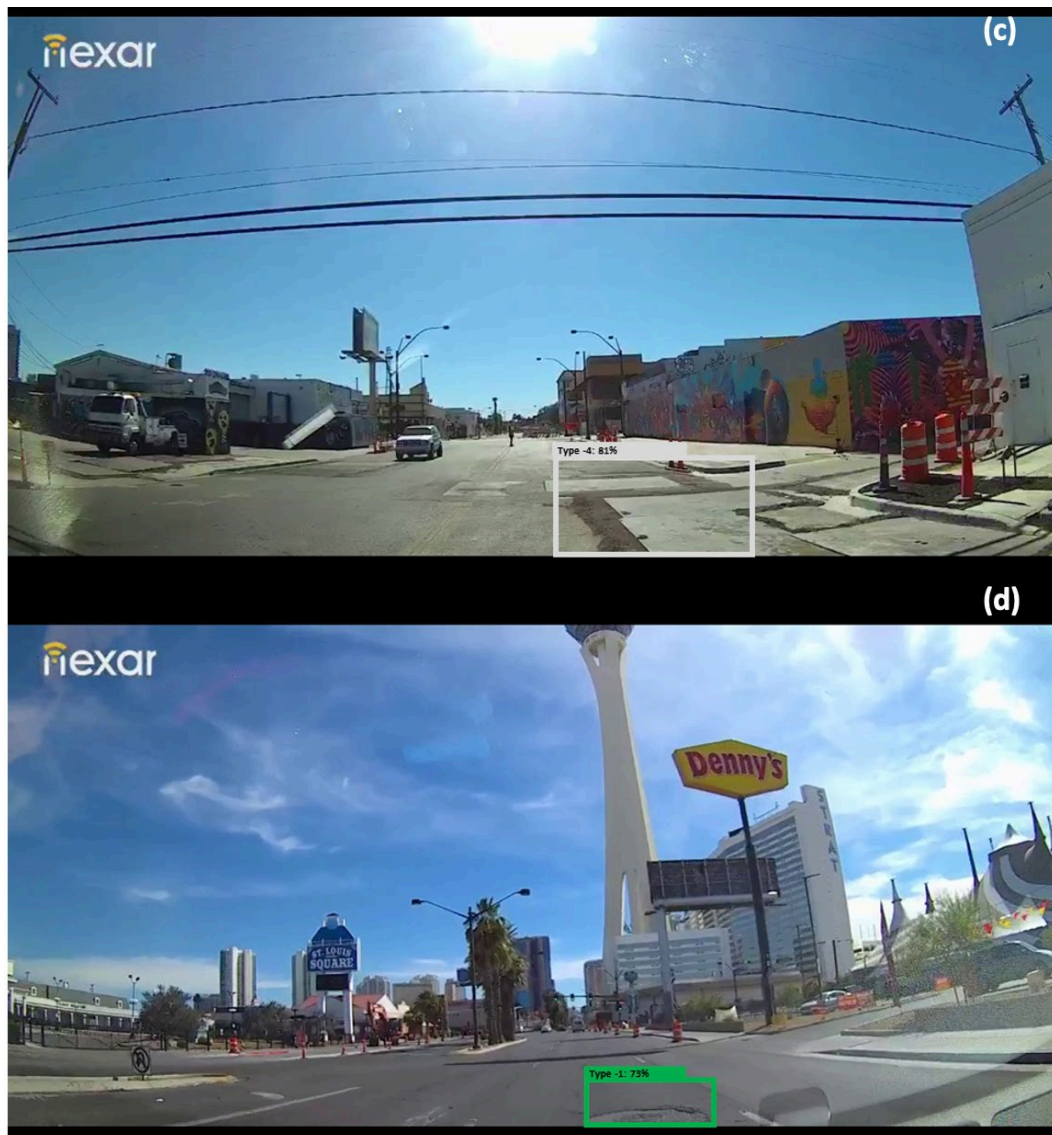
Finally, an error analysis was conducted on false positive (FP) and false negative (FN) instances. Examples of FP are shown in Figure 7. In some cases, the windshield stickers and reflections were the reason for the FP instances (Figure 7(a)). There were also instances where the side curb and their edges were detected as pavement damages (Figure 7(b)). In Figure 7(c) and Figure 7(d), a utility hole and a steel road plate were detected as pavement distress. In some cases, shadows on the ground were the source of the FN error. FP cases are defined as instances of pavement damage that the model was not able to detect. Patching was not detected in many cases. This could be because of the low number of patching instances in the training dataset.

Figure 7. Sample error of detection models.

Figure 7 (cont.). Sample error of detection models.
